DEPARTMENT OF TRANSPORTATION

Quality Assurance and Source Inspection

Contract #: 04-0120F4Cty: SF/ALA Rte: 80 PM: 13.2/13.9File #: 99.28**WELDING INSPECTION REPORT****Resident Engineer:**Siegenthaler, Peter**Address:** 333 Burma Road**City:** Oakland, CA 94607**Report No:** WIR-019130**Date Inspected:** 05-Jan-2011**Project Name:** SAS Superstructure**OSM Arrival Time:** 700**Prime Contractor:** American Bridge/Fluor Enterprises, a JV**OSM Departure Time:** 1900**Contractor:** Zhenhua Port Machinery Company, Ltd (ZPMC)**Location:** Shanghai, China**CWI Name:** Li Yang and Zhu Zhong Hai**CWI Present:** Yes No**Inspected CWI report:** Yes No N/A**Rod Oven in Use:** Yes No N/A**Electrode to specification:** Yes No N/A**Weld Procedures Followed:** Yes No N/A**Qualified Welders:** Yes No N/A**Verified Joint Fit-up:** Yes No N/A**Approved Drawings:** Yes No N/A**Approved WPS:** Yes No N/A**Delayed / Cancelled:** Yes No N/A**Bridge No:** 34-0006**Component:** OBG Trial Assembly**Summary of Items Observed:**

Orthotropic Box Girder (OBG) at Trial Assembly Areas

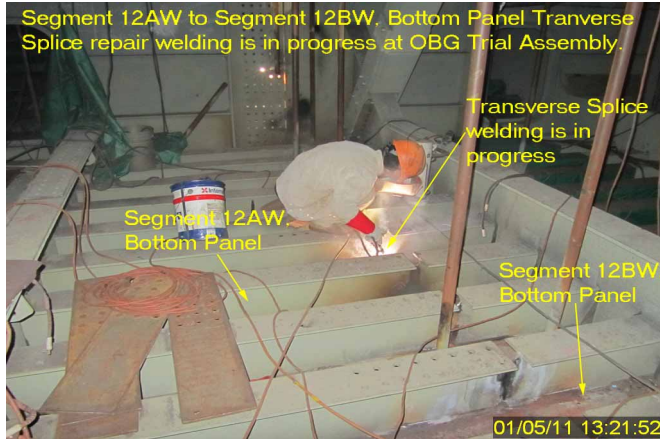
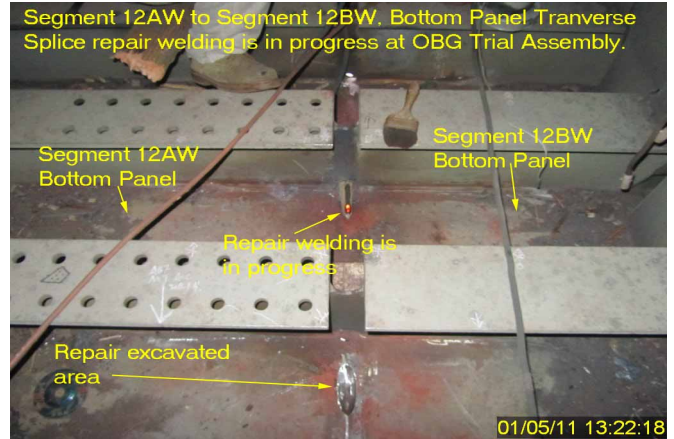
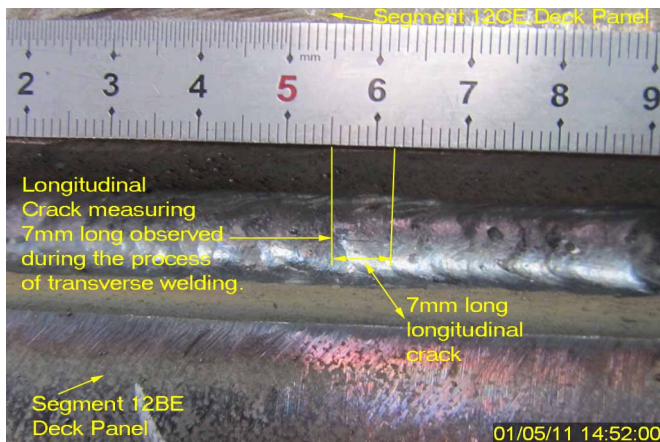
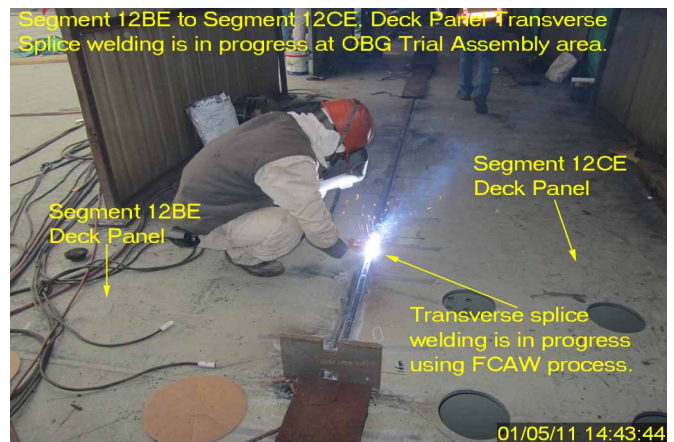
Observed flatness measured out of the allowable tolerance.

This QA Inspector observed the repair welding by Shielded Metal Arc Welding (SMAW) process on a Complete Joint Penetration (CJP) groove weld. The Weld joint was designated as OBE12B-001. The welder identification was 046709 and 046704 and was observed welding in the 1G (Flat) position using approved Welding Procedure Specification WPS-345-SMAW-1G(1F)-FCM-Repair-1. The piece mark was identified as weld connecting Bottom Panel Transverse Splice.

This QA Inspector observed the in-process welding by Flux Cored Arc Welding (FCAW) process on a Complete Joint Penetration (CJP) groove weld. The Weld joint was designated as OBE12A-003. The welder identification was 040456 and 040367 and was observed welding in the 1G (Flat) position using approved Welding Procedure Specification WPS-B-T-223(2)1T-ESAB. The piece mark was identified as the Deck Panel, transverse splice weld.

This QA Inspector at Segment 12BE to Segment 12CE observed longitudinal cracks during welding of Complete Joint Penetration (CJP) groove transverse splice at root run. The welding was performed with the Flux Cored Arc Welding (FCAW) process using ESAB E71T-1M Dual Shield70 Ultra Plus electrode with ceramic backing. Longitudinal Cracks was visually evident at Deck Panel, weld joint number identified as OBE12A-003.
